Manhole Inspection Summary

Manhole # S43E2_013MH

Insp Date: **1/2/08 9:18 AM**

Location Address: **1200 Church St**

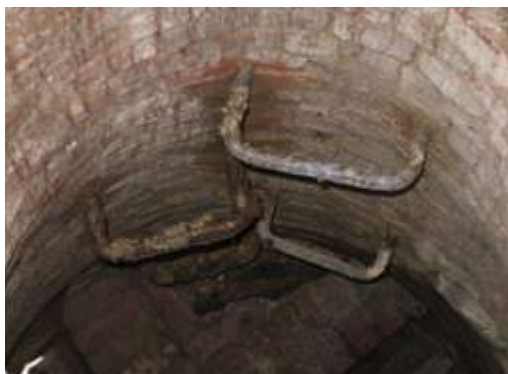
Steps

Count: **4** Missing: **0** ☐ Corroded

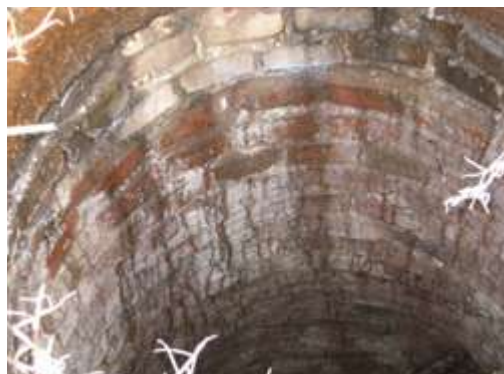
Defect 2

Condition: ☐ Sound ☒ **Cracked** ☐ Root Intrusion ☐ Loose Brick ☐ Deteriorated

Infiltration: ☐ None ☐ Joint ☒ **Cracks** ☐ Mortar ☐ Roots ☒ **Wall**

Wall

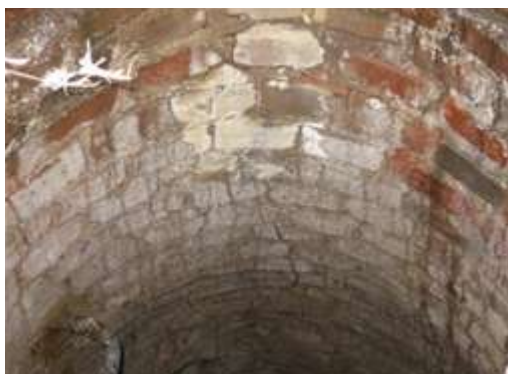
Defect 1

Infiltration: ☐ None ☐ Joint ☒ **Cracks** ☐ Mortar ☐ Roots ☒ **Wall**

Cracks

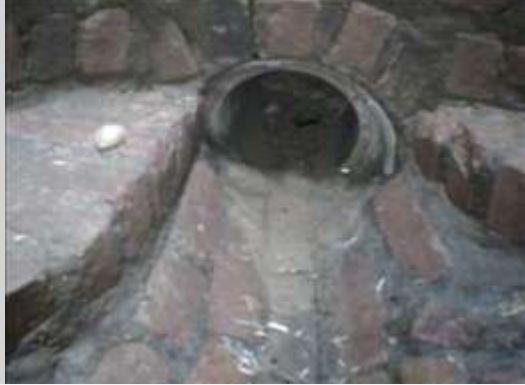
12 O'Clock Outflow

Pipe Height: **8.4** (in.) Rod and Bar (Angled)
Pipe Material: **Clay** ☐ Pipe Lined
Invert Depth: **10.59** (ft.) Flow Characteristics: **None**
Deposits: ☒ None ☐ Mud ☐ Sludge ☐ Debris ☐ Grease
Silt Depth: (in.) Deposits Extent:
Infiltration: **None** Pipe Seal Cond: **Sound**

Connects To: **Dead End**

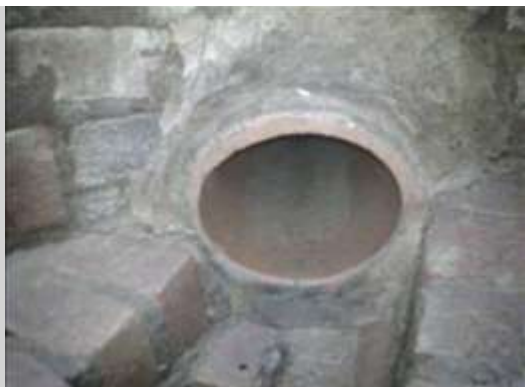
3 O'Clock Inflow

Pipe Height: **7.2** (in.) Rod and Bar (Angled)
Pipe Material: **Clay** ☐ Pipe Lined
Invert Depth: **9.67** (ft.) Flow Characteristics: **None**
Deposits: ☒ None ☐ Mud ☐ Sludge ☐ Debris ☐ Grease
Silt Depth: (in.) Deposits Extent:
Infiltration: **None** Pipe Seal Cond: **Sound**

Connects To: **House connection / Service line**

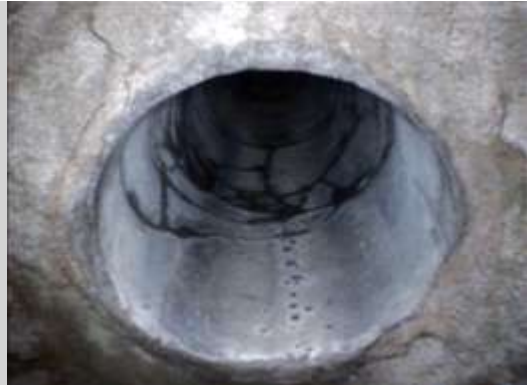
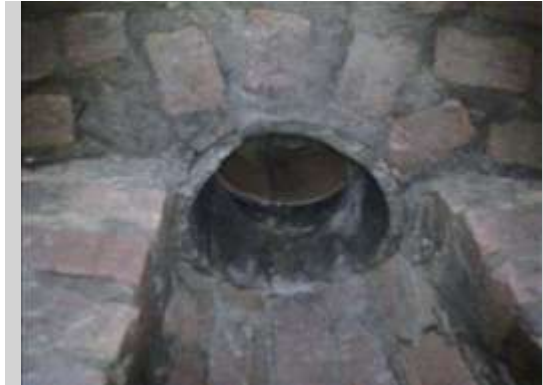
6 O'Clock Inflow

Pipe Height: **9.6** (in.) Rod and Bar (Angled)

Pipe Material: **Clay** ☐ Pipe Lined

Invert Depth: **5.91** (ft.) Flow Characteristics: **None**

Infiltration: **None** Pipe Seal Cond: **Cracked**

Drop: **Outside** Rod and Bar

Angled: **Yes** Reading: **8.87** (ft.)

Inv Depth: **9.87** (ft.)

Drop Condition: **Open**

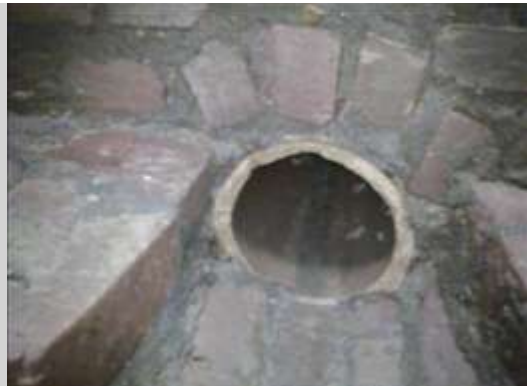
9 O'Clock Inflow

Pipe Height: **7.2** (in.) Rod and Bar (Angled)

Invert Depth: **10.01** (ft.) Flow Characteristics: **None**

Infiltration: **None** Pipe Seal Cond: **Sound**
